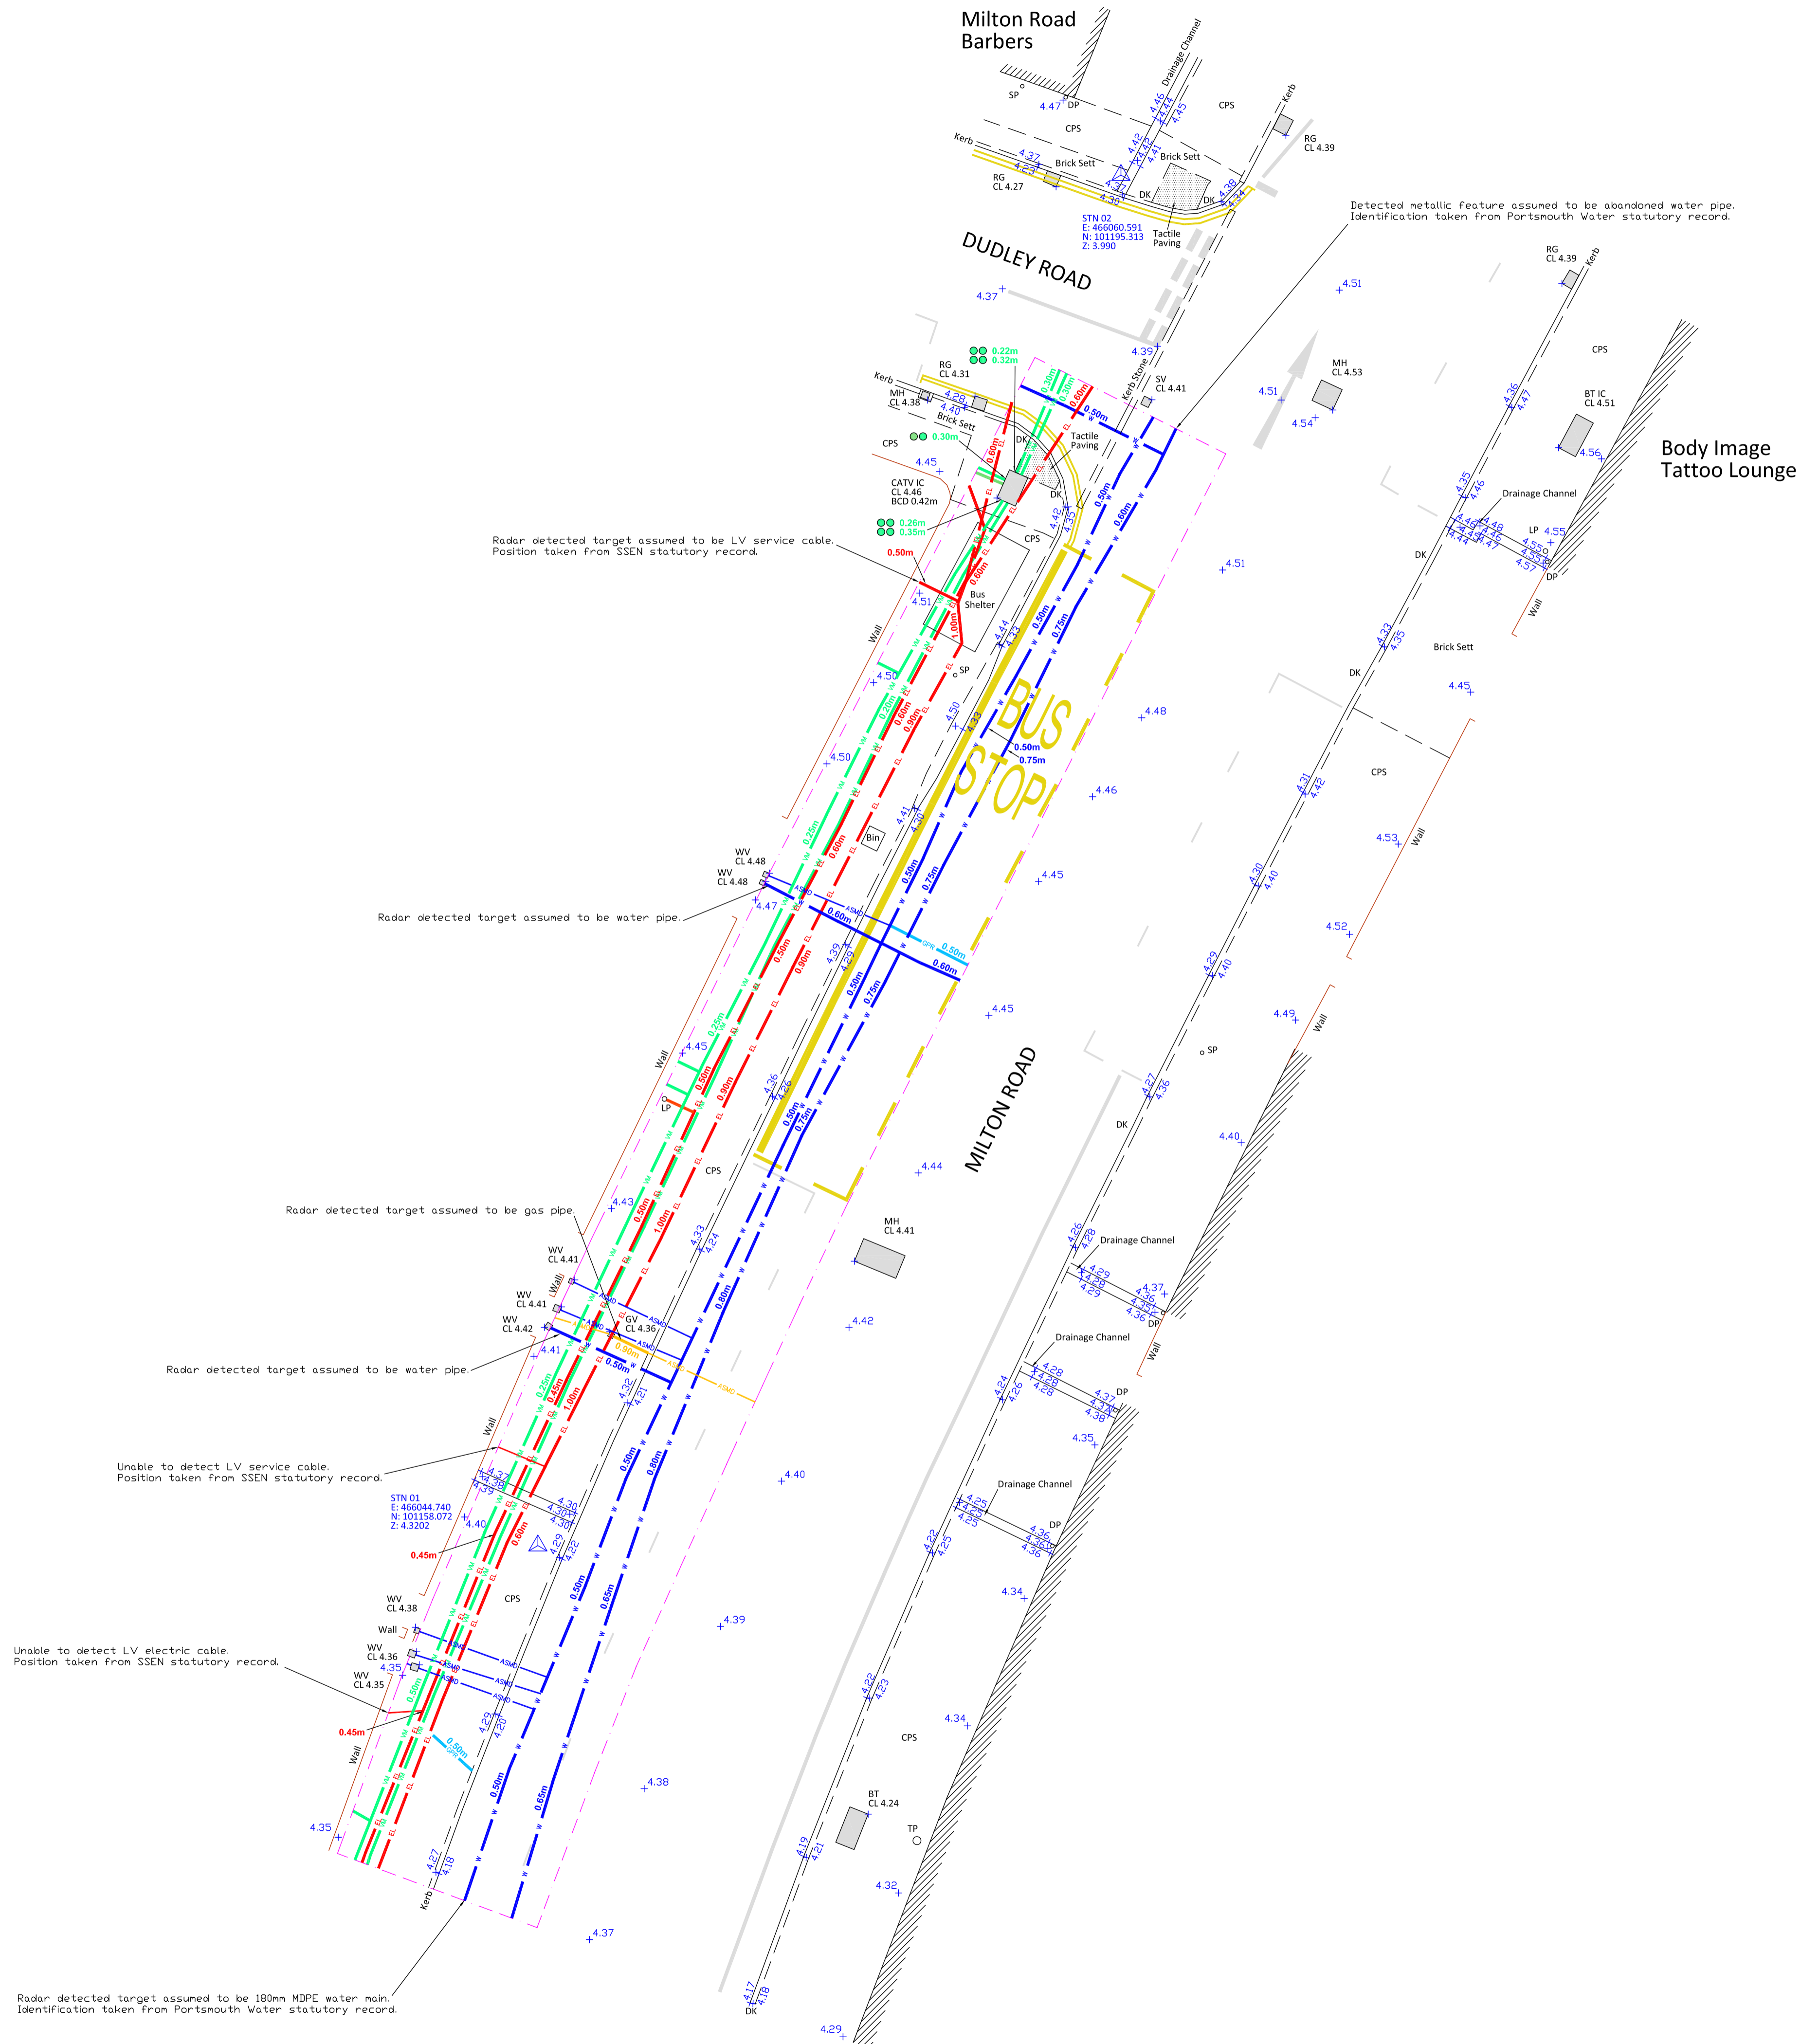
A variety of detection technologies were used to produce the underground information recorded for this non-invasive survey. Variations in ground conditions, depth and density of services and signal interference from surrounding features can affect the accuracy of these technologies, therefore 100% detection and accuracy cannot be guaranteed.

All utility/service depths are in metres and are taken to the top of utility/service unless otherwise stated.

All pipe/duct sizes are in millimetres unless otherwise stated.

Pipe sizes are shown from visual inspection or taken from statutory information.

All dimensions measured by tape at manholes and inspection covers are determined from ground level due to non-entry of chambers, therefore these should be treated as indicative only.

Underground services shown on this drawing are illustrated by a single service line. This single service line may actually represent multiple cables and/or ducts.

An anomalous feature is an unidentified subsurface area evident within the radar data that differs in response to its surrounding area. Examples of anomalous features include voiding, heavily saturated ground, buried tanks and demolished building foundations.

Topographical survey control is to OSGB36(15) datum by GPS (as recorded at the time of acquisition) and the project rotated to North, all subsequent data acquired does not have a scalefactor applied and therefore is based on a flat earth scenario.
